DOE/NASA/20370-20
NASA TM-82594

Aluminum Blade Development for the Mod-0A 200-Kilowatt Wind Turbine

Bradford S. Linscott and Richard K. Shaltens
National Aeronautics and Space Administration
Lewis Research Center

December 1981

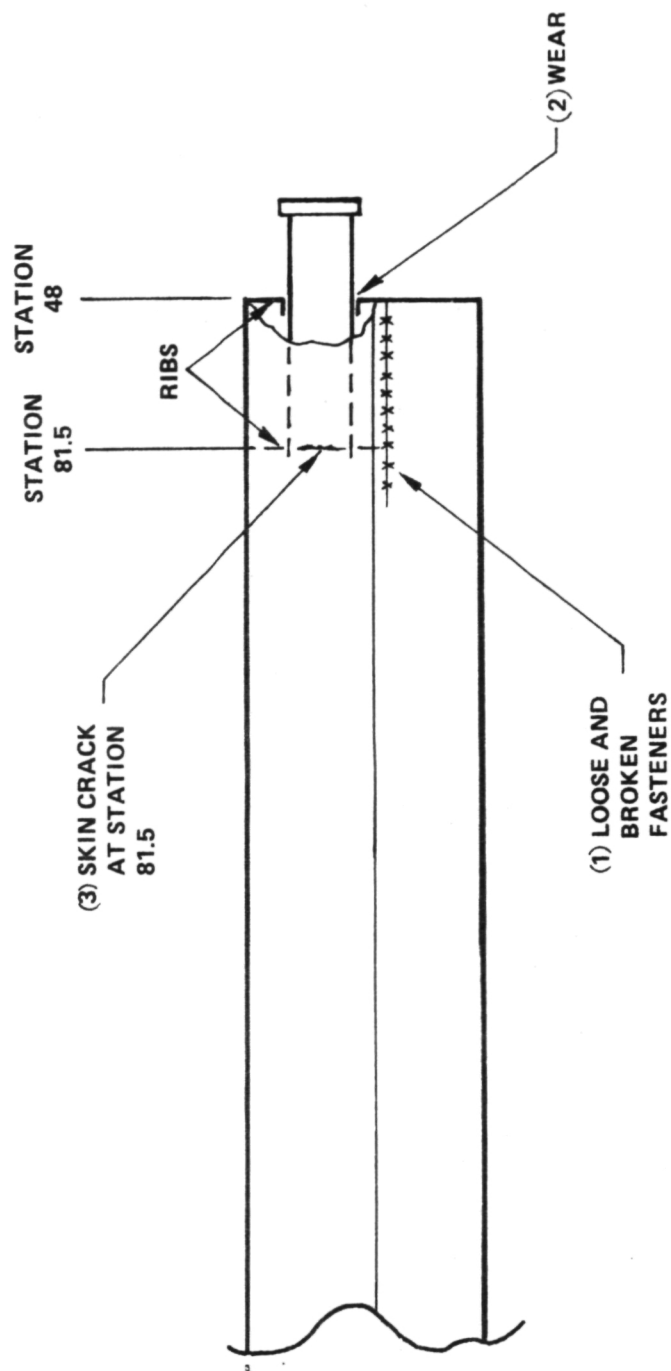
During the blade inspection at the Lewis Research Center, three types of blade damage were found. Figure 14 illustrates the nature and location of the damage. The damage included (1) loose and broken fasteners, (2) wear, and (3) cracking. It was concluded that damage at (1) was due to a design deficiency located along the line of fasteners joining the trailing edge skin to the D-spar (fig. 15). It was determined that the joint could not carry the applied shear loads shown in figure 15. The shear loads occur primarily due to the chordwise bending moments, blade weight being a major contributor. As a result, broken and loose fasteners were found, and cracks were found in several angle stringers located in the root end of the D-spar. This design deficiency was corrected by adding doublers on the exterior of the blade between station 48 and 100 as shown in figures 16 and 17.

Figure 14. - Mod-OA blade damage.

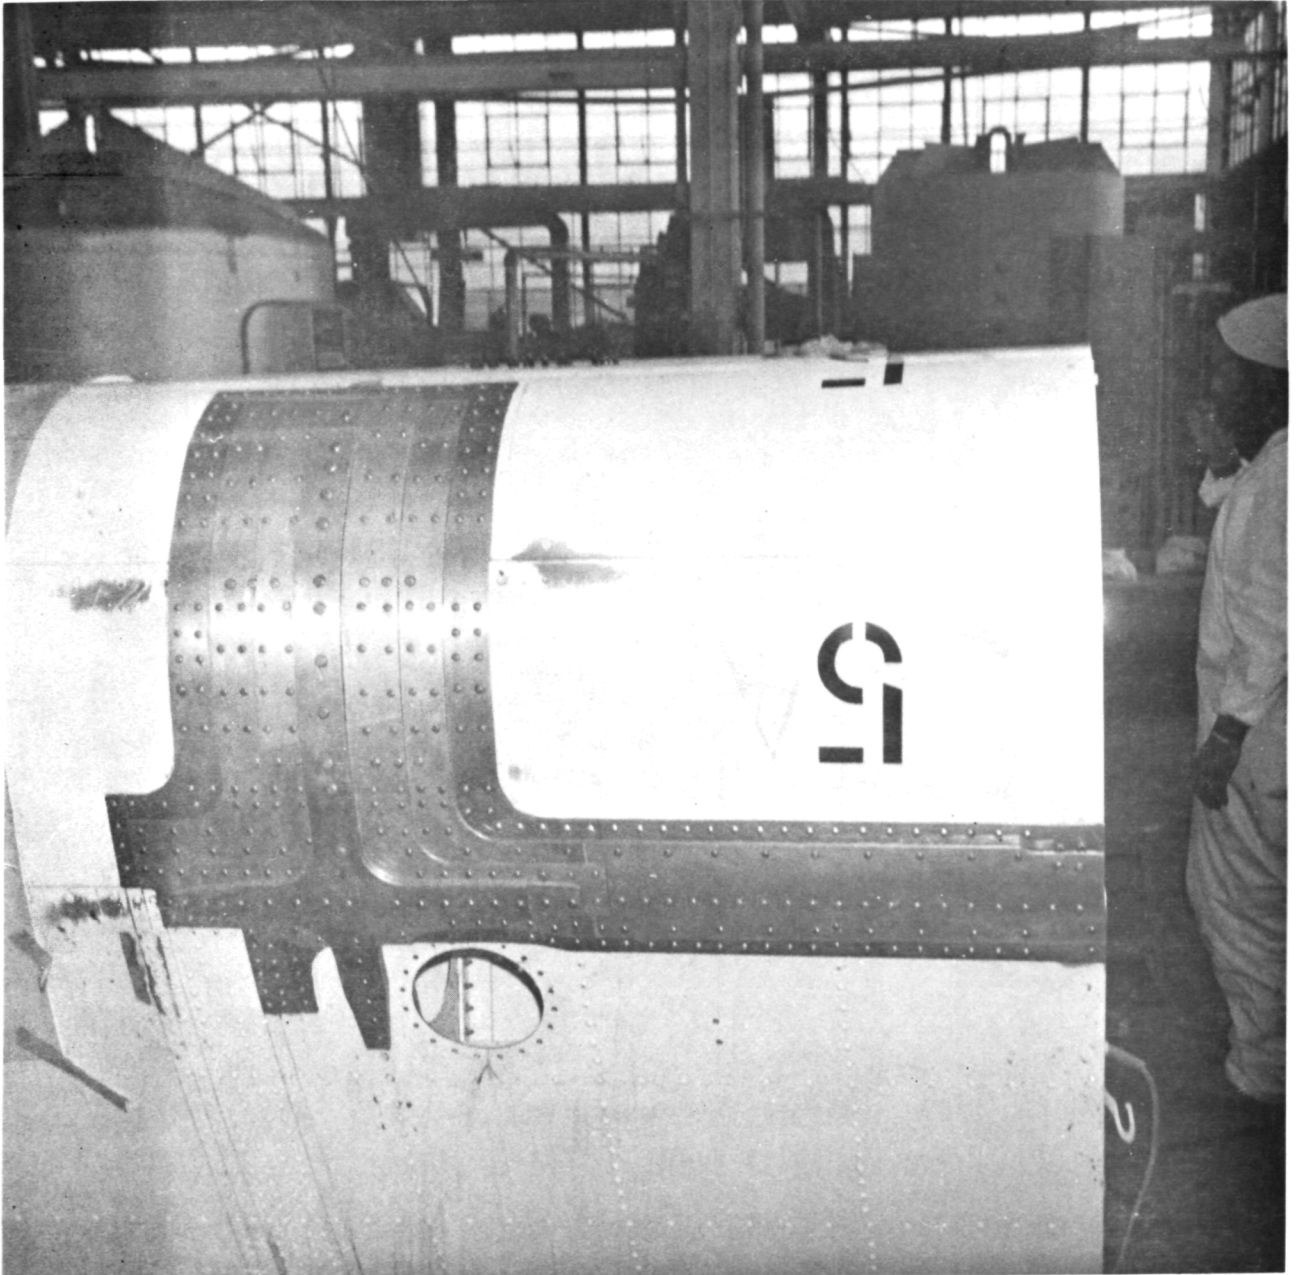
Figure 16. MOD-0A Blade SN 1005 Doublers

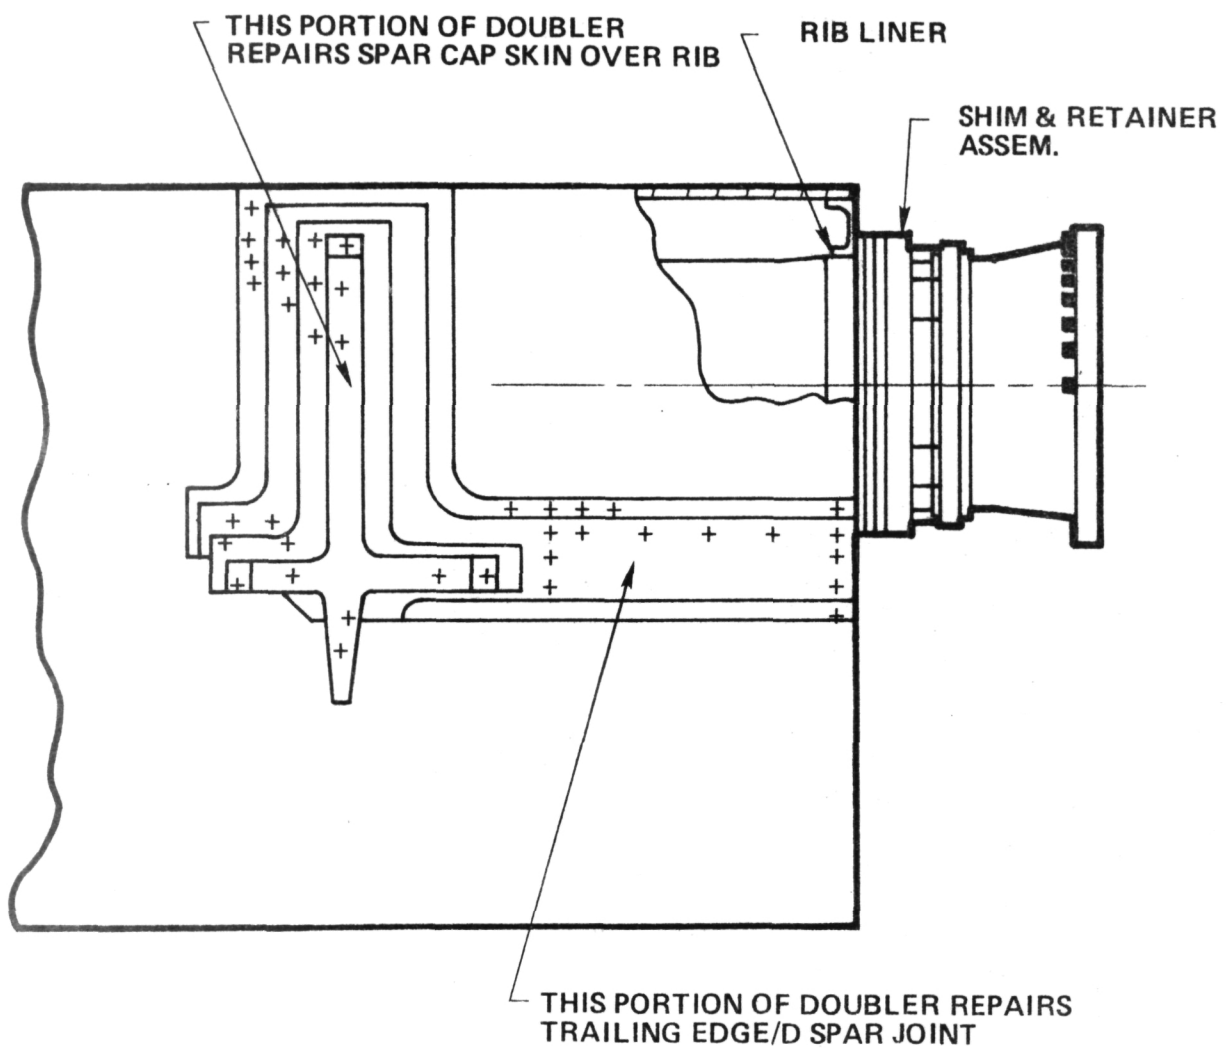
Figure 17. - Initial Mod-OA blade repairs and modifications.

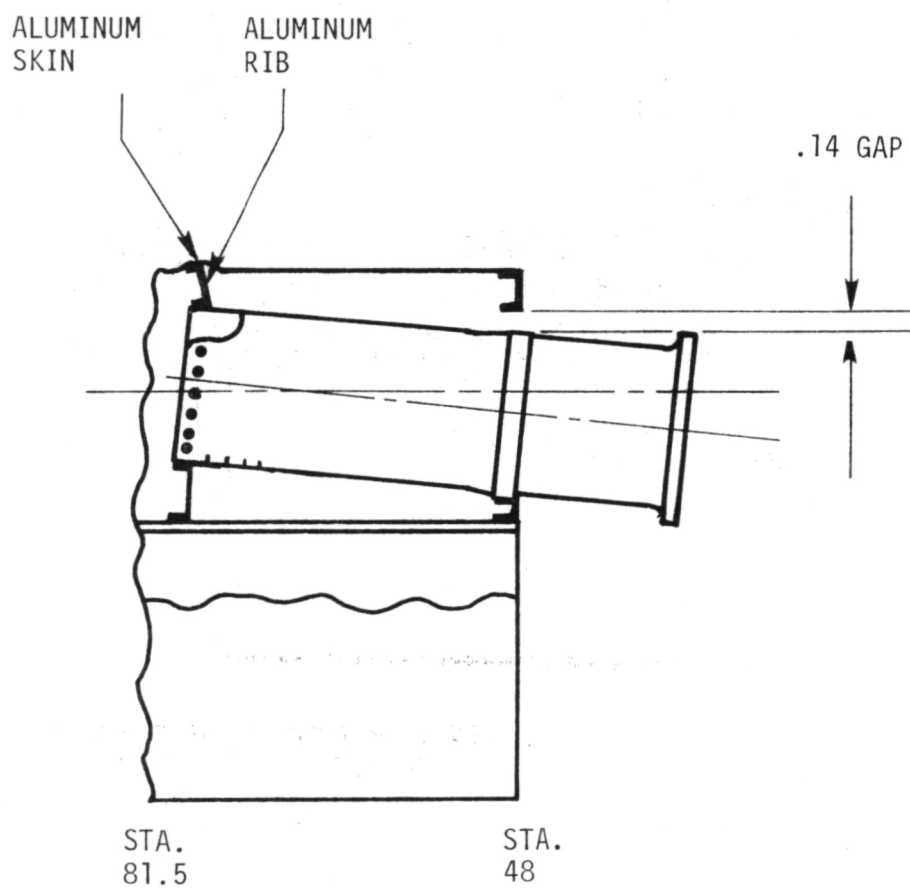
A second design deficiency was located at the bearing interface between the aluminum rib, at station 48, and the steel root end fitting, shown in figure 18. It was observed during the blade inspection at the Lewis Research Center that the steel root end fitting had rubbed extensively on the station 48 aluminum rib during operation (fig. 8 shows the detail design). This rubbing action caused excessive wear (damage at (2) in fig. 14) of the aluminum rib. The wear resulted in a radial clearance of up to 0.14 inch between the root end fitting and the rib on the blade. Because of the increased radial clearance at station 48, a large bending moment was applied to the rib at station 81.5. It was concluded that the high bending moments applied to the station 81.5 rib caused the rib to crack and that the rib/D-spar skin contact forces caused the 0.25-inch thick D-spar skin to crack (damage at (3) in fig. 14). The D-spar crack was repaired by the doublers shown in figures 16 and 17 which also effectively increase the skin thickness. A special bearing assembly (figs. 19 and 20) was designed and installed to solve the wear problem at the rib/root fitting sliding interface at station 48. The redesign included a Be-Cu liner bonded to the inside diameter of the rib and a removable shim inserted between the rib and the root fitting.

Figure 18. - Mod-OA blade station 48 interface wear problem.

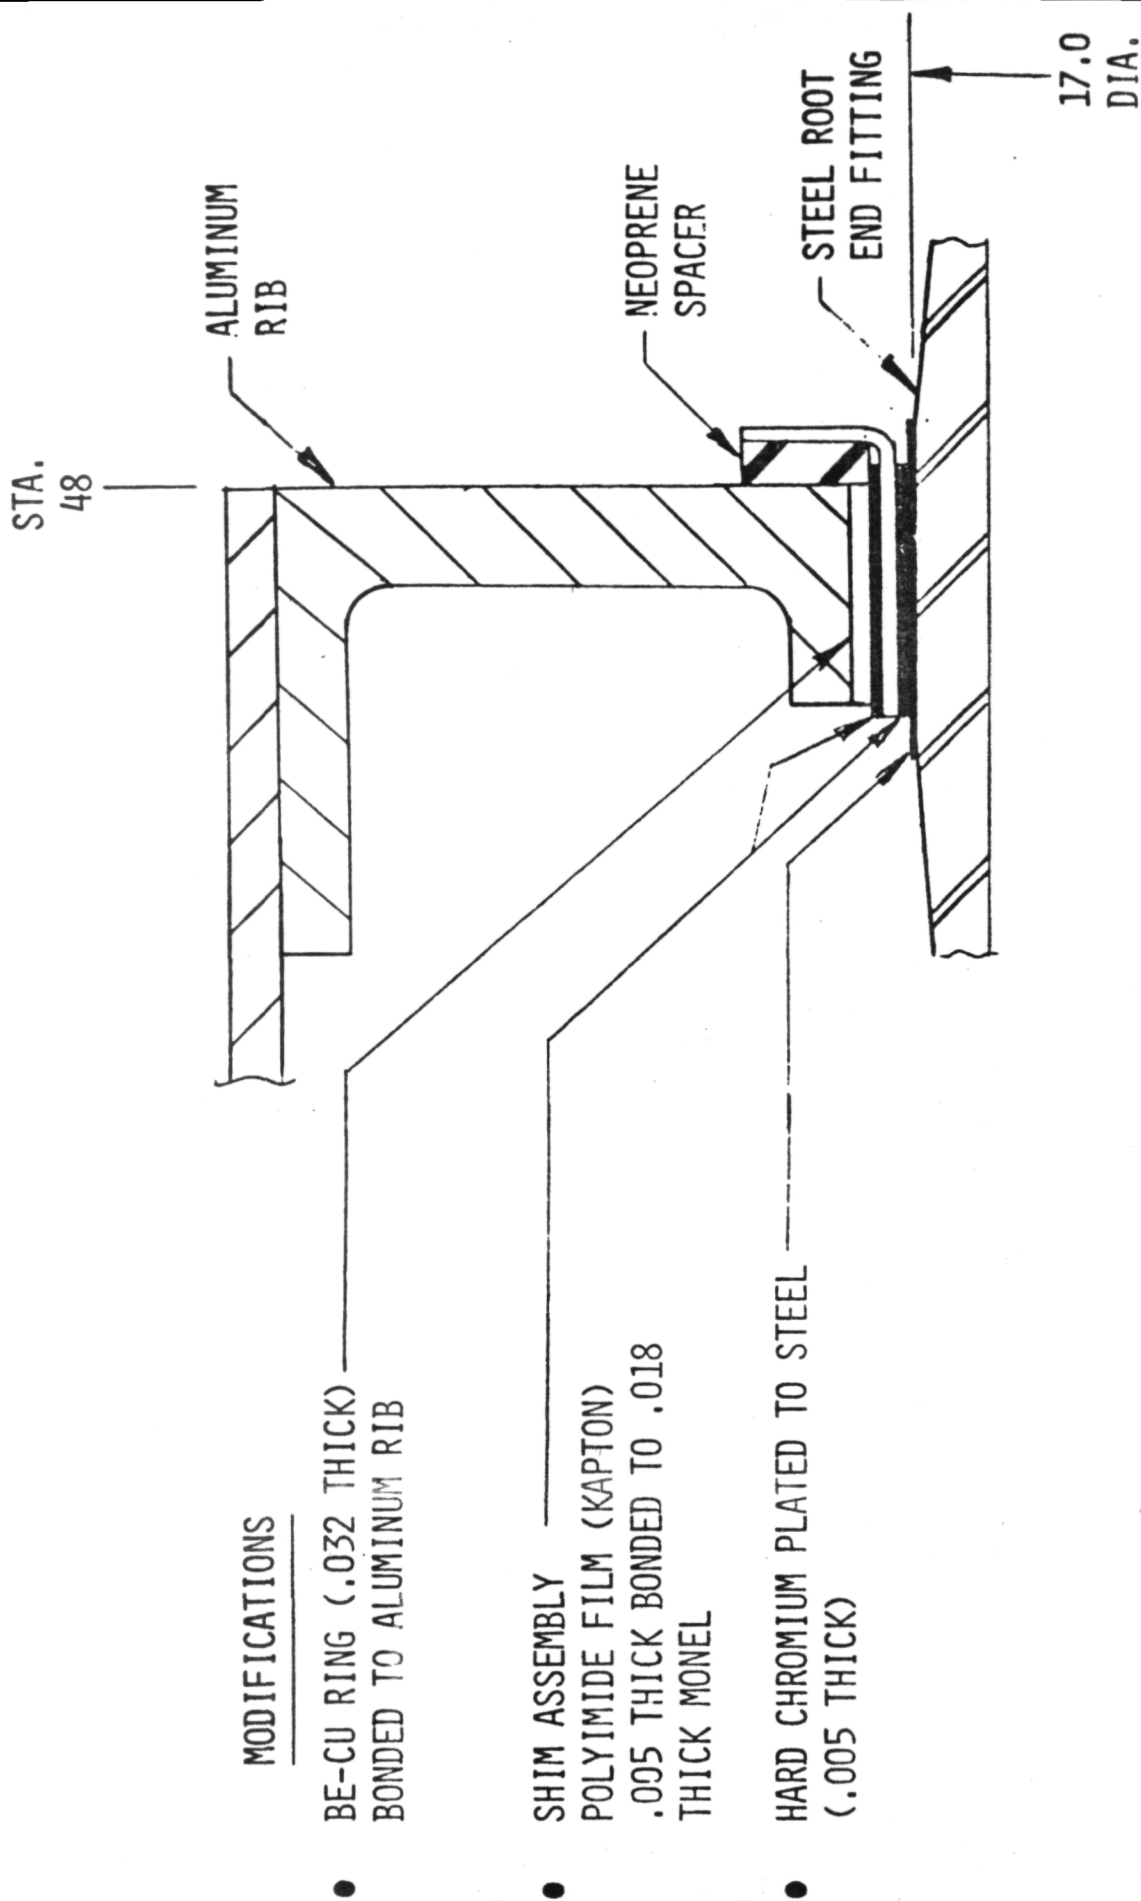
Figure 19. Mod-0A blade. Installation of beryllium copper liner and shims.

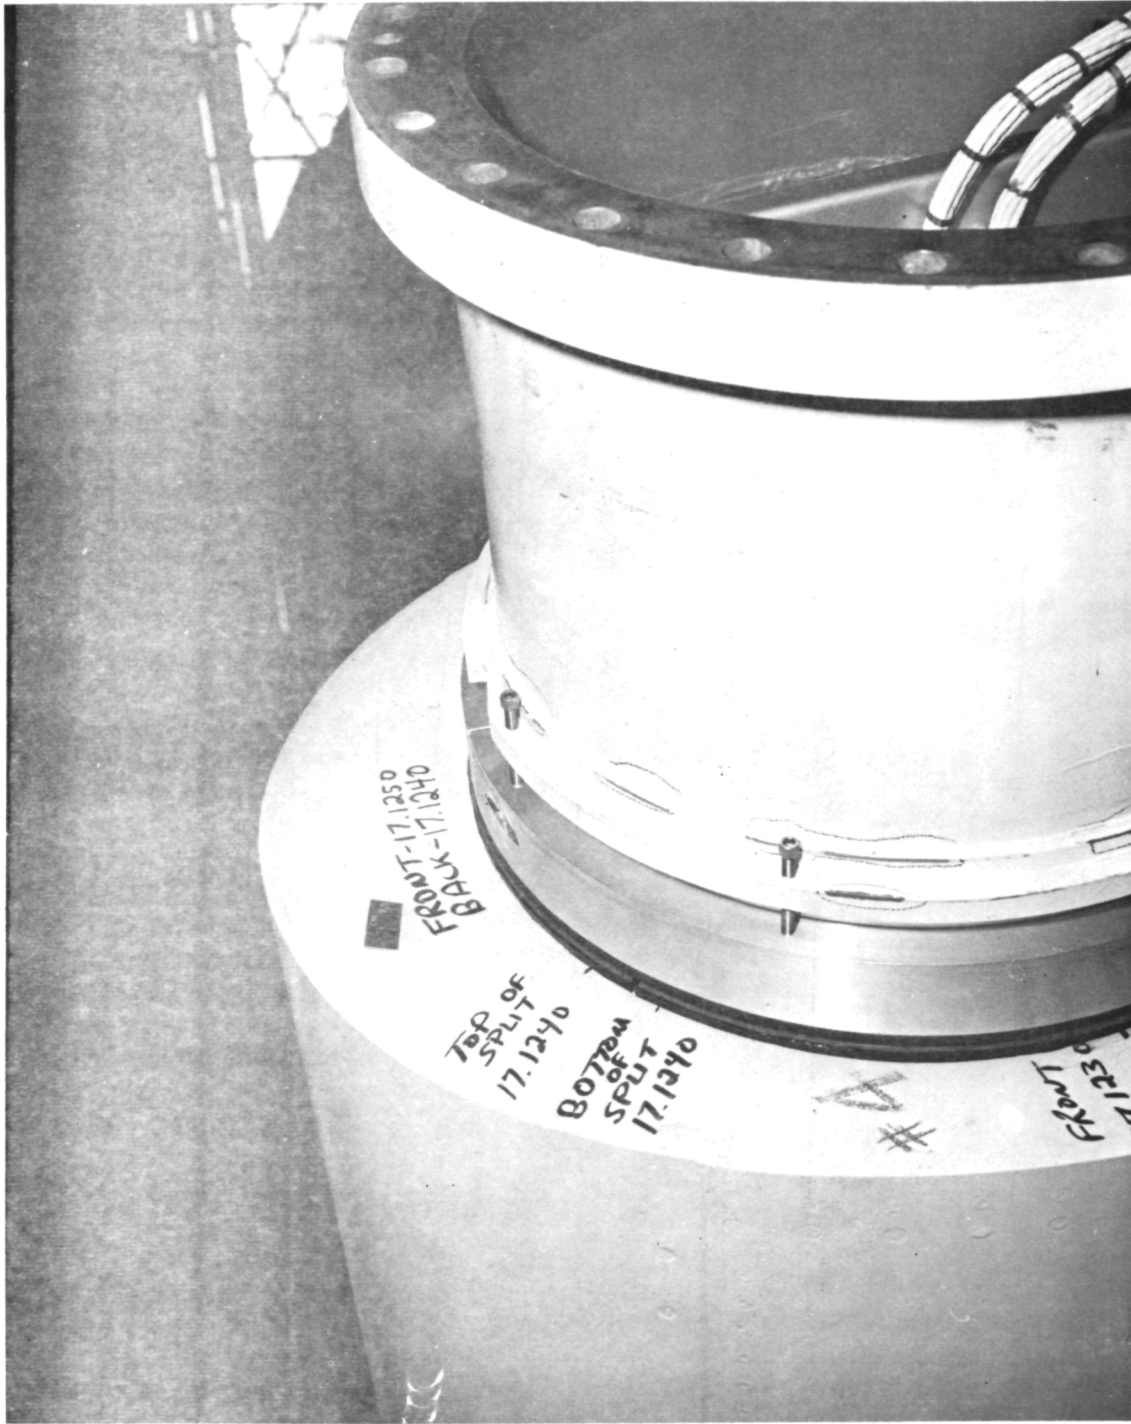
Figure 20. MOD-OA Blade SN 1004 with Station 48 Rib/Root Fitting Bearing Modifications

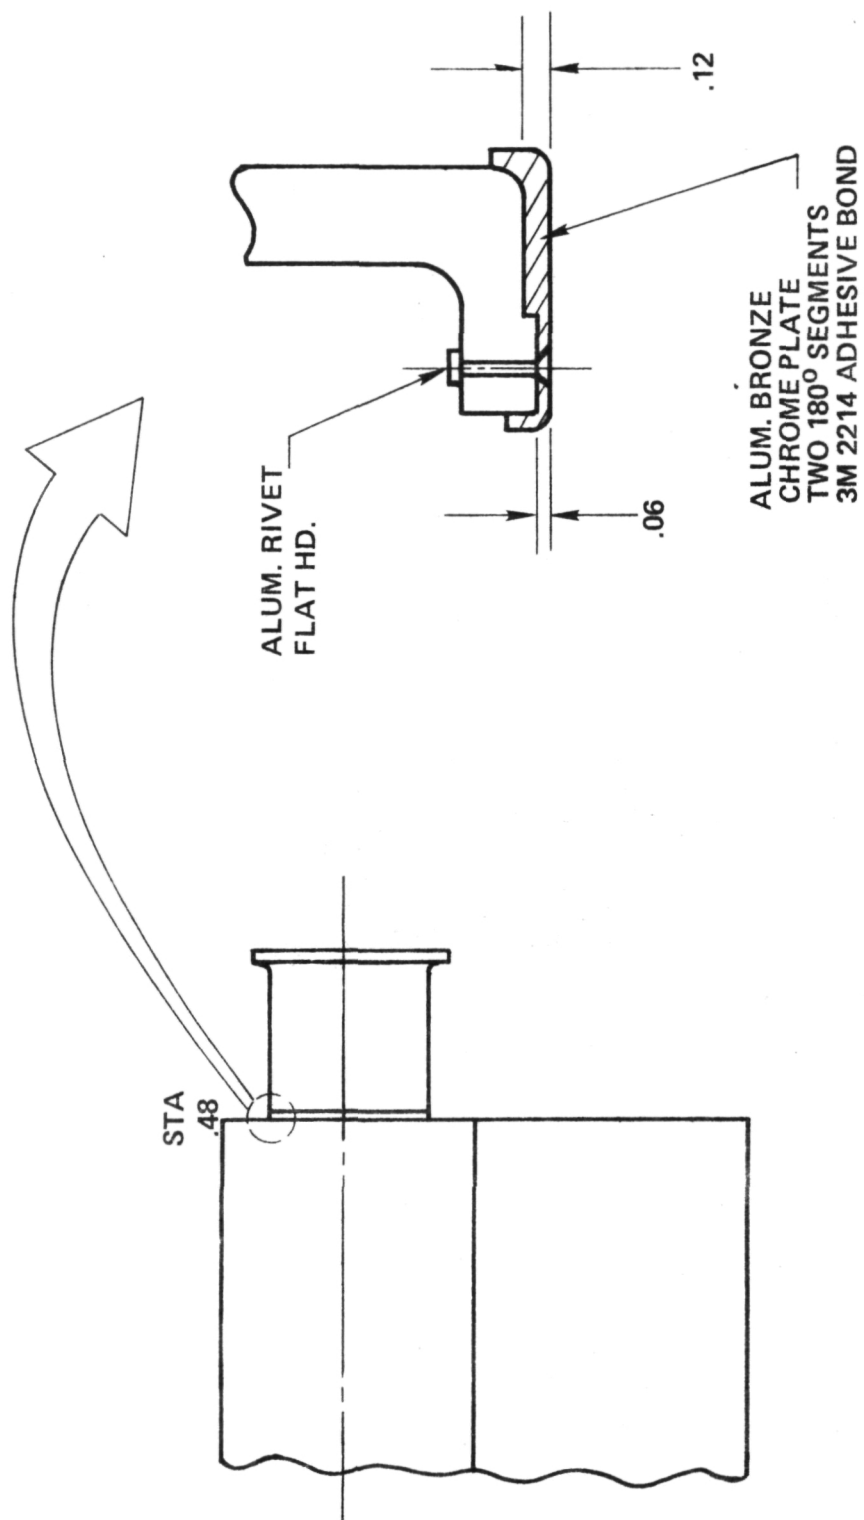
When the Be-Cu liner bond joint at station 48 rib failed, the liner shifted out of the rib producing a large gap (0.032 in.) between the root end fitting and rib. It was concluded that bending overloads in the station 81.5 rib had occurred again as the station 48 joints opened and closed, thus producing the observed damage. A new and modified liner (redesigned Be-Cu ring) was installed in each blade. A shoulder was provided on the outside

Figure 21. - Aluminum bronze liner for station 48 rib.

of the liner (in addition to the bond) to retain it. A structural doubler was installed to repair the web panel and the blades were reassembled.

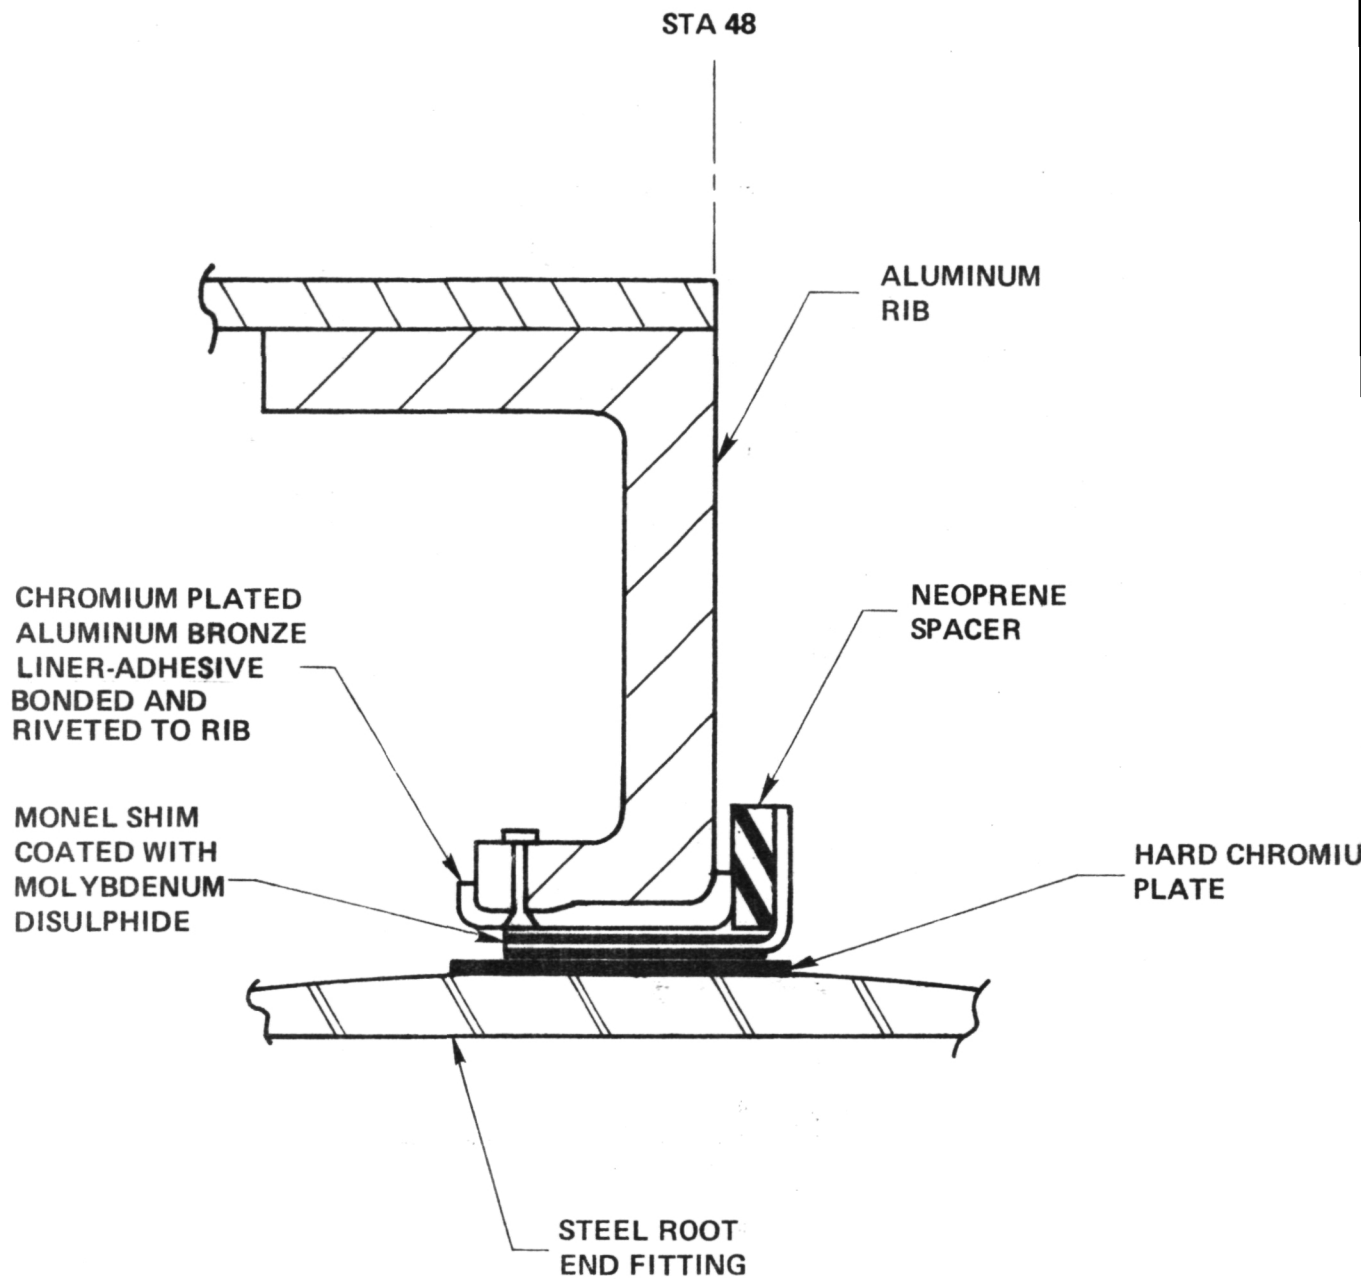
Figure 22. - Bearing assembly at station 48 with aluminum bronze liner.
